**Flood Control Project Maintenance
Levee Inspections**
LMA District Cover Sheet
Spring 2018 Levee Inspection Results

Reclamation District No. 0537 Lovdal

Spring 2018 Levee Inspection Results

Waterway			Bank	Unit Miles
Unit No. 01 Sacramento River			Right	4.74
	Spring (March - May)	Summer (June - August)	(September - November) Fall	Winter (December - February)
Unit Maintenance Rating (Fall Only)				
Date of Inspection	5/1/2018 - 5/1/2018			
DWR Inspector	Zach Jojola			
Accompanied By	Oleg Yakimov DWR			
	David Julian DWR

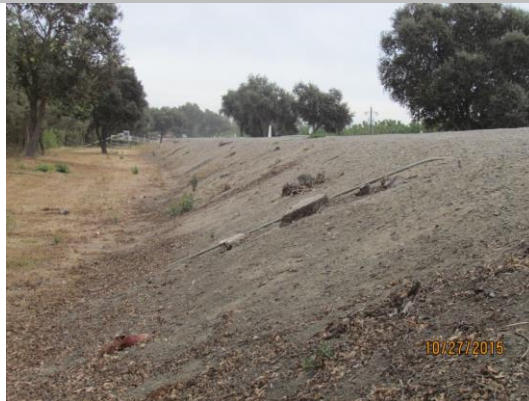
Photo 1 of 1 : SP_2018_RD0537_173_22_20180306_00018.jpg

View of the tree stumps on the waterward side of the levee looking downstream. Fall 2015.

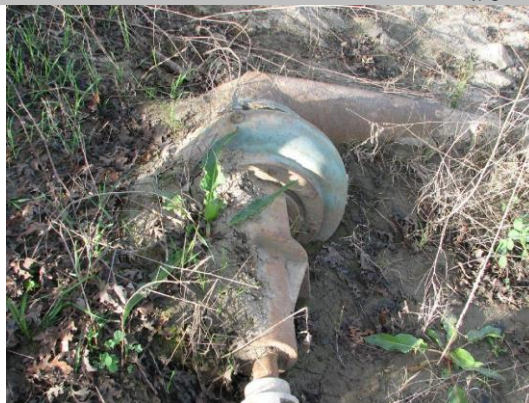
Photo 1 of 3 : UCIP_SP_2018_50087_17140.jpg

UCIP Comments: 07/18/2016 - Same as last inspection. Pipe severely corroded. Since it is a deep irrigation pipe, cracking on pavement likely not caused by pipe. (K. Fazel/UCIP)03/18/2013 - Crossing appears abandoned; if so, must be done so properly. Cracking on pavement along pipe alignment. Holes visible on pipe along WS slope. (P. Amatya/UCIP)

FIELD_STRUCT_DESC: *ABANDONED* 10-inch steel irrigation discharge pipe through the levee, 18 feet below the crown. Centrifugal pump on the waterside (WS). Concrete collar on the WS per permit drawing, not found in 2016. Polyvinyl chloride (PVC) standpipe and valve enclosed by a concrete standpipe off the landside (LS) toe, likely not associated with the crossing, per Ken Lang of Reclamation District No. 537 (RD0537). 1-inch electrical conduit through the levee, 3.8 feet below the crown, this may not be associated with the crossing, per Ken Lang. (Plans for the installation of a pumping plant with a 10-inch discharge pipe through the levee authorized under Permit No. 558, 1932 - A. Marty and Brothers). Current adjacent landowner is the Giovenetti Ranch, but the pipe is not used by the landowner.

WS- an abandoned pump.

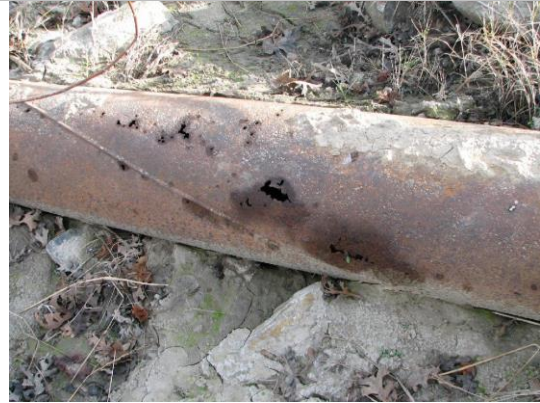
Photo 3 of 3 : UCIP_SP_2018_50087_17142.jpg

Comment Code						
Inspector Comment						
FS_ID:50087 DS_ID:169 EP_NO: 558 Repair Type: Urgent Crossing Status: Found UCIP Comments: 07/18/2016 - Same as last inspection. Pipe severely corroded. Since it is a deep irrigation pipe, cracking on pavement likely not caused by pipe. (K. Fazel/UCIP)03/18/2013 - Crossing appears abandoned; if so, must be done so properly. Cracking on pavement along pipe alignment. Holes visible on pipe along WS slope. (P. Amatya/UCIP) FIELD_STRUCT_DESC: *ABANDONED* 10-inch steel irrigation discharge pipe through the levee, 18 feet below the crown. Centrifugal pump on the waterside (WS). Concrete collar on the WS per permit drawing, not found in 2016. Polyvinyl chloride (PVC) standpipe and valve enclosed by a concrete standpipe off the landside (LS) toe, likely not associated with the crossing, per Ken Lang of Reclamation District No. 537 (RD0537). 1-inch electrical conduit through the levee, 3.8 feet below the crown, this may not be associated with the crossing, per Ken Lang. (Plans for the installation of a pumping plant with a 10-inch discharge pipe through the levee authorized under Permit No. 558, 1932 - A. Marty and Brothers). Current adjacent landowner is the Giovenetti Ranch, but the pipe is not used by the landowner. [Additional Reference(s): DWR Levee Log, 2004, referenced as 8.3 feet below the crown]. Permit drawing issued in 1932 indicates that the pipe depth is 6.7 feet; however, permit was issued prior to the construction of a new levee prism above the old levee in 1955. FS Date: 7/18/2016

WS- visible holes on the pipe.

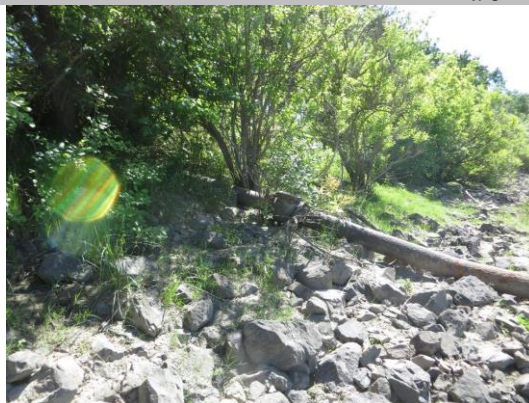
Photo 1 of 3 : UCIP_SP_2018_46803_74402.jpg

Comment Code						
Inspector Comment						
FS_ID:46803 DS_ID:168 EP_NO: N/A Repair Type: Non-Urgent Crossing Status: Found UCIP Comments: Crossing appears abandoned; if so, must be done so properly. FIELD_STRUCT_DESC: *ABANDONED* 10-inch coated steel irrigation discharge pipe, 3.8 feet below the crown. Pump is gone. Concrete pump pad on the waterside (WS) bank, not found. 36-inch concrete standpipe off the landside (LS) toe. 2-inch electrical conduit through the levee, not found. 1-inch electrical conduit found for the 10-inch pipe located 50 feet upstream. Plate bolted to the WS end of the pipe. [Additional Reference(s): DWR Levee Log, 2004]. FS Date: 4/29/2015

Pipe visible along WS slope.

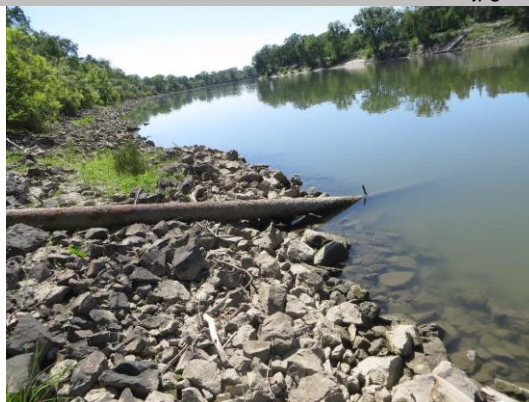
Photo 2 of 3 : UCIP_SP_2018_46803_74403.jpg

View of pipe into water.

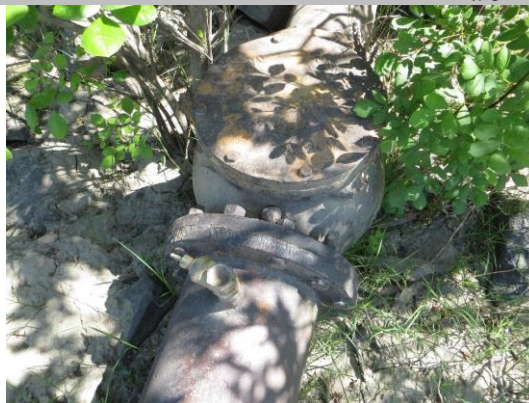
Photo 3 of 3 : UCIP_SP_2018_46803_74404.jpg

Comment Code						
Inspector Comment						
FS_ID:46803 DS_ID:168 EP_NO: N/A Repair Type: Non-Urgent Crossing Status: Found UCIP Comments: Crossing appears abandoned; if so, must be done so properly. FIELD_STRUCT_DESC: *ABANDONED* 10-inch coated steel irrigation discharge pipe, 3.8 feet below the crown. Pump is gone. Concrete pump pad on the waterside (WS) bank, not found. 36-inch concrete standpipe off the landside (LS) toe. 2-inch electrical conduit through the levee, not found. 1-inch electrical conduit found for the 10-inch pipe located 50 feet upstream. Plate bolted to the WS end of the pipe. [Additional Reference(s): DWR Levee Log, 2004]. FS Date: 4/29/2015

Closeup of plates bolted to pipe on WS slope.

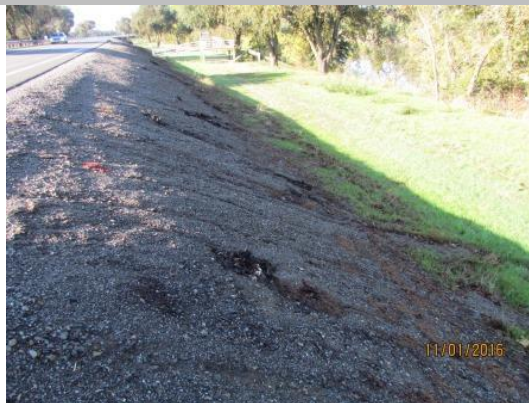
Photo 1 of 1 : SP_2018_RD0537_173_34_20180306_00027.jpg

LM Start	0.13	Rating **	A/W	Issue No.	55
LM End	0.13	Issue Type +	Ma	Location *	WS
Category	Earthen Levee			GPS Latitude/Longitude	
				Start	End
Item	Erosion / Bank Caving			38.644158 °	38.644158 °
				-121.582337 °	-121.582337 °
DWR ID	DWR_RD0537_01_f_2017_55				
Comment Code					
E1 : Note and monitor erosion site.					
Inspector Comment					
Runoff erosion on waterside slope. Recommend monitoring.

Runoff erosion on waterside slope. Fall 2016.

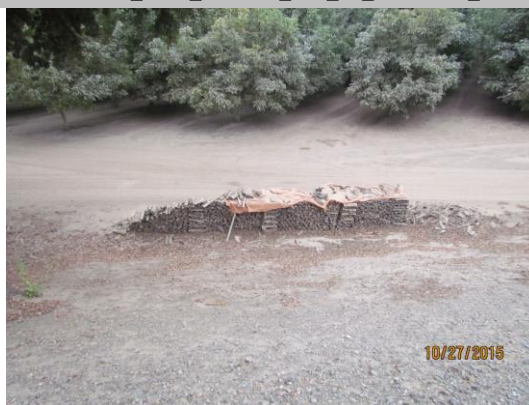
Photo 1 of 3 : SP_2018_RD0537_173_47_20180306_00042.jpg

LM Start	0.38	Rating **	M	Issue No.	47
LM End	0.38	Issue Type +	En	Location *	LS
Category	Earthen Levee			GPS Latitude/Longitude	
				Start	End
Item	Encroachments			38.646457 °	38.646457 °
				-121.578663 °	-121.578663 °
DWR ID	DWR_RD0537_01_s_2012_47				
Comment Code					
FW : Firewood					
Inspector Comment

View of the firewood pile at the toe of the levee on the landward side. Fall 2015.

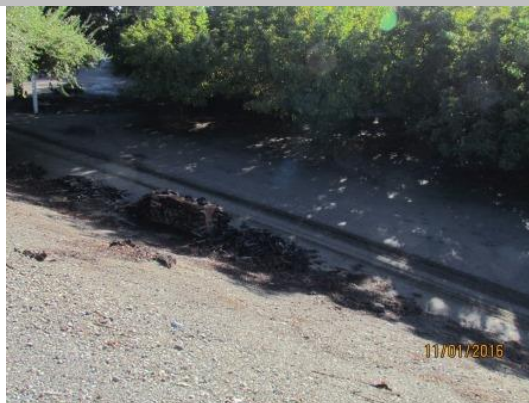
Photo 2 of 3 : SP_2018_RD0537_173_47_20180306_00043.jpg

Updated view of firewood at LS toe. Fall 2016.

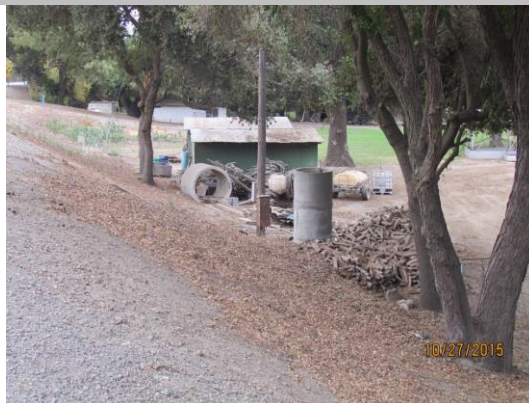
Photo 3 of 3 : SP_2018_RD0537_173_47_20180306_00044.jpg

Perspective view of more firewood at the toe of the levee on the landward side looking downstream. Fall 2015.

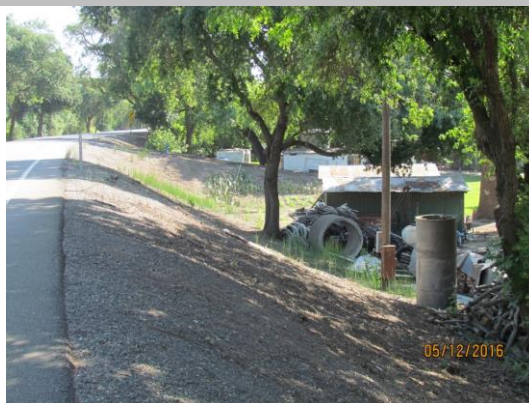
Photo 1 of 2 : SP_2018_RD0537_173_6_20180306_00003.jpg

LM Start	0.39	Rating **	M	Issue No.	6
LM End	0.39	Issue Type +	En	Location *	LS
Category	Earthen Levee			GPS Latitude/Longitude	
				Start	End
Item	Encroachments			38.646557 °	38.646557 °
				-121.578529 °	-121.578529 °
DWR ID	DWR_RD0537_01_s_2013_6				
Comment Code					
EQ : Equipment					
Inspector Comment					
Also building is in the easement.

View of the equipment at the toe of the levee looking downstream. Spring 2016.

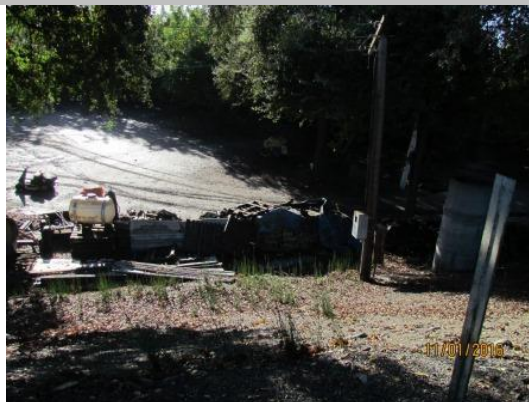
Photo 2 of 2 : SP_2018_RD0537_173_6_20180306_00004.jpg

Updated view of equipment at landside toe. Fall 2016.

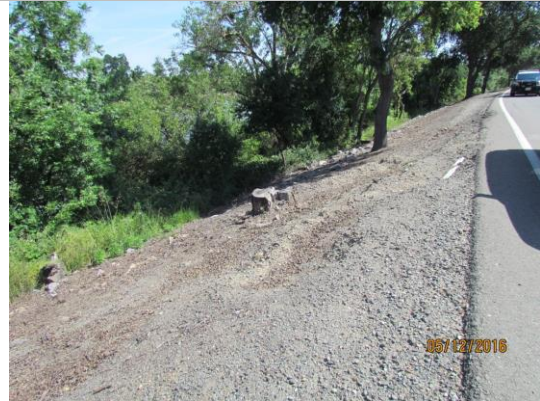
Photo 1 of 1 : SP_2018_RD0537_173_31_20180306_00024.jpg

LM Start	0.42	Rating **	M	Issue No.	31
LM End	0.42	Issue Type +	Ma	Location *	WS
Category	Earthen Levee			GPS Latitude/Longitude	
				Start	End
Item	Slope Stability			38.646811 °	38.646811 °
				-121.578241 °	-121.578241 °
DWR ID	DWR_RD0537_01_s_2016_31				
Comment Code					
S3 : Repair the levee slope damaged by vehicle traffic and prevent access where possible.					
Inspector Comment

View of the slope stability near the shoulder of the waterward side of the levee looking downstream. Spring 2016.

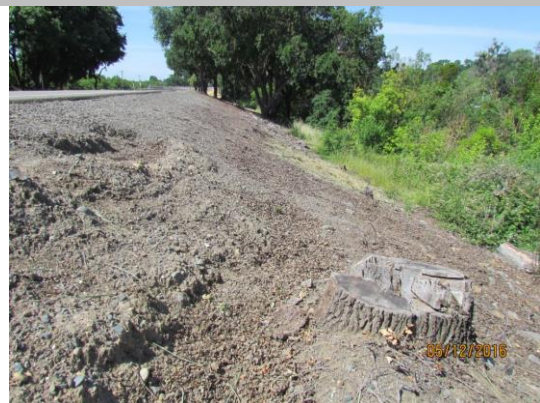
Photo 1 of 1 : SP_2018_RD0537_173_32_20180306_00025.jpg

LM Start	0.42	Rating **	N	Issue No.	32
LM End	0.42	Issue Type +	Ma	Location *	WS
Category	Earthen Levee			GPS Latitude/Longitude	
				Start	End
Item	Trim / Thin Trees			38.646811 °	38.646811 °
				-121.578241 °	-121.578241 °
DWR ID	DWR_RD0537_01_s_2016_32				
Comment Code					
T5 : Tree stumps.					
Inspector Comment

View of the tree stump on the waterward side of the levee looking downstream. Spring 2016.

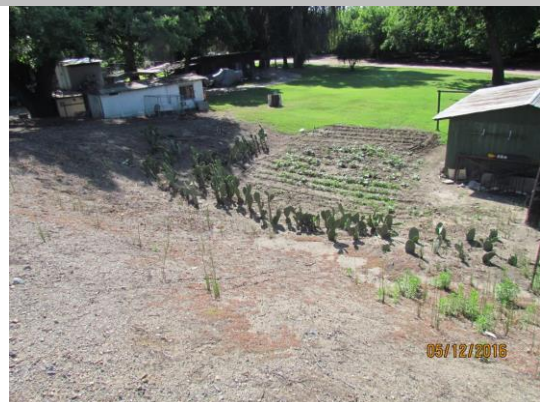
Photo 1 of 2 : SP_2018_RD0537_173_18_20180306_00016.jpg

View of the cactus at the toe of the levee. Spring 2016.

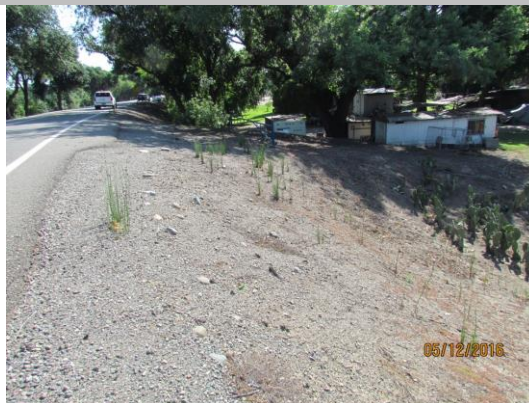
Photo 2 of 2 : SP_2018_RD0537_173_18_20180306_00017.jpg

Perspective view of the landscaping on the landward side of the levee looking downstream. Spring 2016.

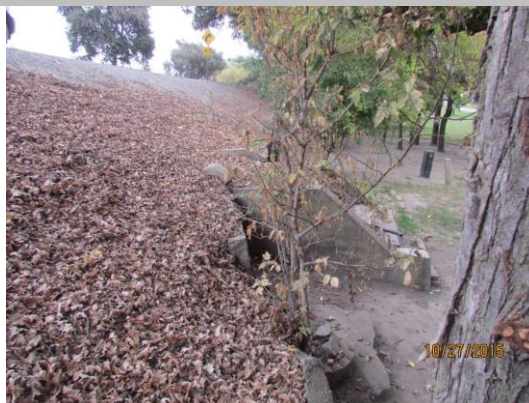
Photo 1 of 3 : SP_2018_RD0537_173_50_20180306_00047.jpg

View of the retaining wall at the levee toe on the landward side of the levee looking downstream. The wall is partially broken. Fall 2015.

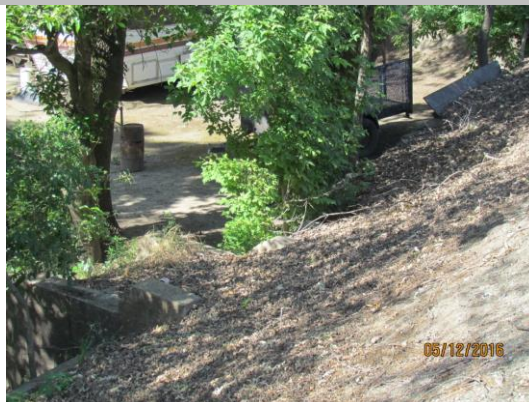
Photo 2 of 3 : SP_2018_RD0537_173_50_20180306_00048.jpg

View of the retaining wall at the toe of the levee on the landward side. Spring 2016.

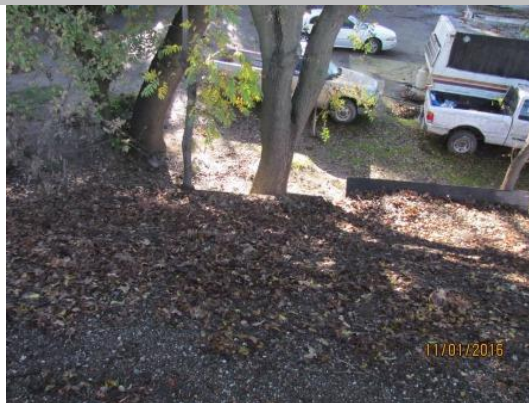
Photo 3 of 3 : SP_2018_RD0537_173_50_20180306_00049.jpg

Updated view of the site. Fall 2016.

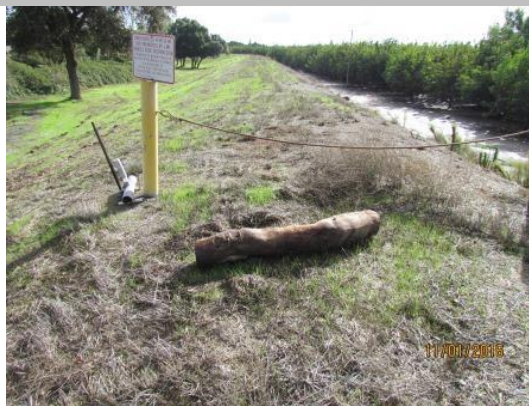
Photo 1 of 1 : SP_2018_RD0537_173_54_20180306_00053.jpg

Debris on levee crown near the gate. Fall 2016.

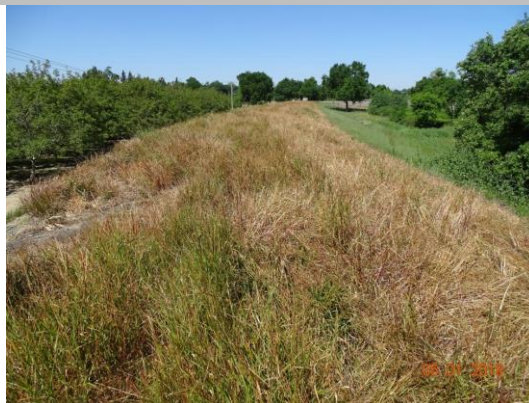
Photo 1 of 1 : SP_2018_RD0537_173_69_20180501_00098.jpg

View of vegetation on the crown. Spring 2018.

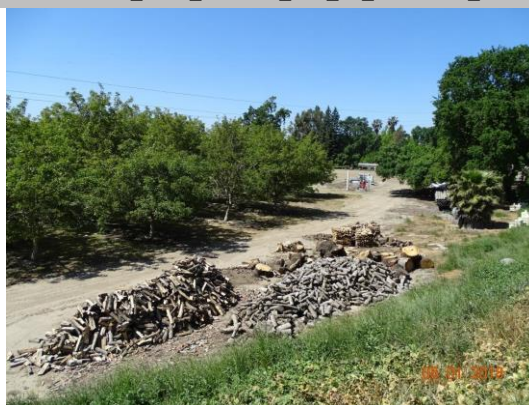
Photo 1 of 2 : SP_2018_RD0537_173_53_20180501_00099.jpg

Large piles of firewood at the landside toe. Spring 2018.

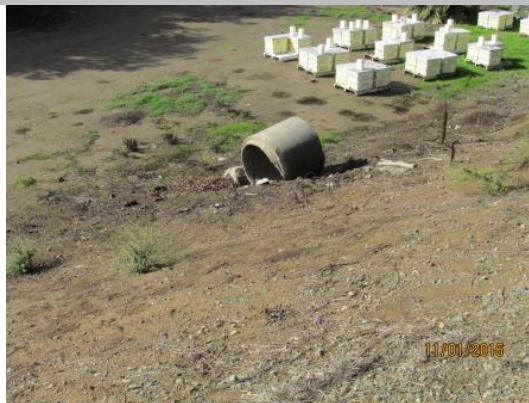
Photo 2 of 2 : SP_2018_RD0537_173_53_20180306_00052.jpg

Concrete ring at landside levee toe. Fall 2016.

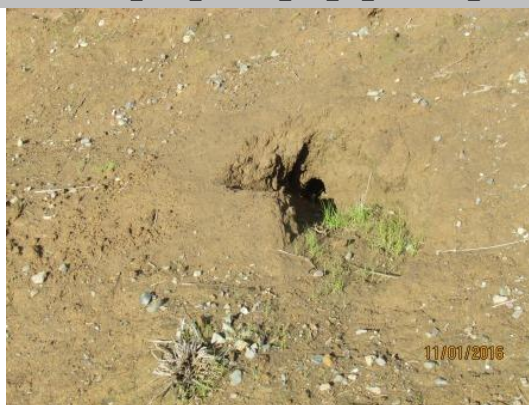
Photo 1 of 1 : SP_2018_RD0537_173_52_20180306_00051.jpg

LM Start	0.64	Rating **	M	Issue No.	52
LM End	0.64	Issue Type +	Ma	Location *	LS
Category	Earthen Levee			GPS Latitude/Longitude	
				Start	End
Item	Erosion / Bank Caving			38.647243 °	38.647243 °
				-121.574580 °	-121.574580 °
DWR ID	DWR_RD0537_01_f_2016_52				
Comment Code					
E2 : Schedule repair of erosion site prior to the next inspection.					
Inspector Comment

Rodent hole has erosion around less than 1ft deep. Fall 2016.

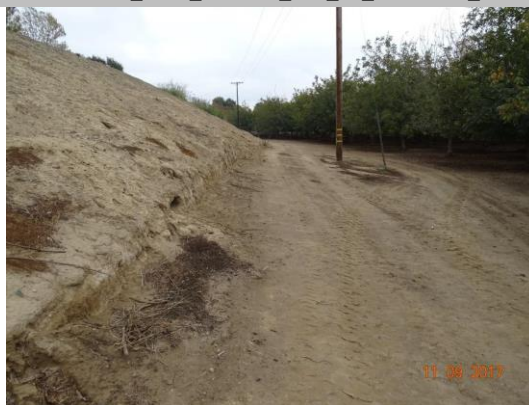
Photo 1 of 1 : SP_2018_RD0537_173_27_20180306_00021.jpg

View of tilling on the landside toe. Fall 2017.

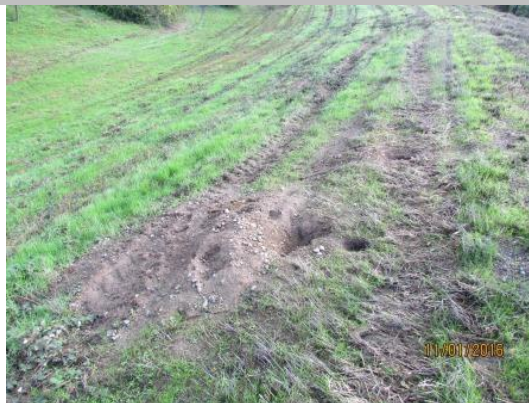
Photo 1 of 1 : SP_2018_RD0537_173_51_20180306_00050.jpg

View of animal burrows on WS slope with large amount of soil out. Fall 2016.

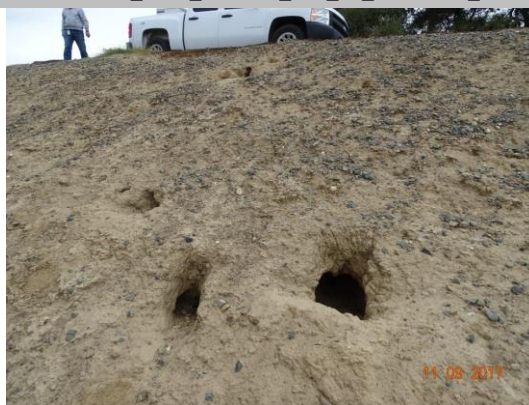
Photo 1 of 1 : SP_2018_RD0537_173_65_20180306_00060.jpg

View of holes on the landside slope. Fall 2017.

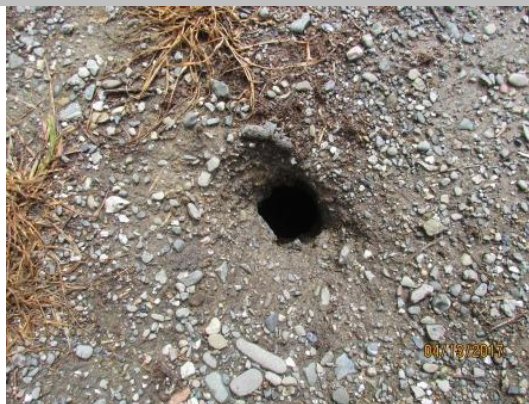
Photo 1 of 1 : SP_2018_RD0537_173_68_20180306_00062.jpg

Deep rodent hole on levee crown. Spring 2017.

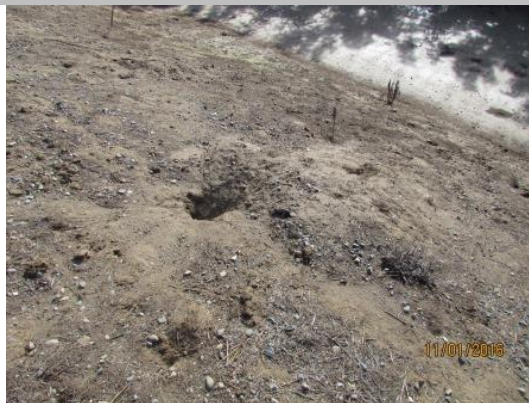
Photo 1 of 1 : SP_2018_RD0537_173_49_20180306_00046.jpg

Animal burrows on LS slope. Fall 2016.

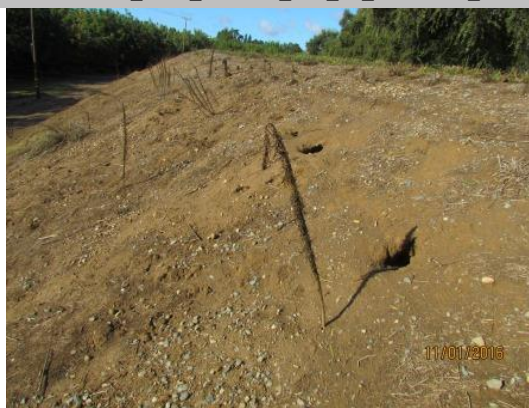
Photo 1 of 1 : SP_2018_RD0537_173_48_20180306_00045.jpg

Animal burrows on LS slope. Fall 2016.

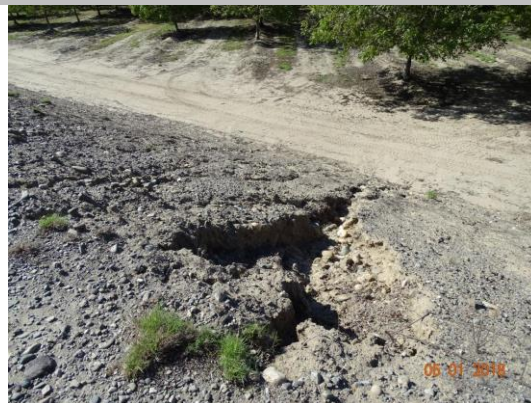
Photo 1 of 2 : SP_2018_RD0537_173_35_20180501_00093.jpg

LM Start	0.81	Rating **	M	Issue No.	35
LM End	0.81	Issue Type +	Ma	Location *	LS
Category	Earthen Levee			GPS Latitude/Longitude	
				Start	End
Item	Erosion / Bank Caving			38.647181 °	38.647181 °
				-121.571586 °	-121.571586 °
DWR ID	DWR_RD0537_01_f_2016_35				
Comment Code					
E2 : Schedule repair of erosion site prior to the next inspection.					
Inspector Comment					
Runoff erosion on landside slope. It has gotten deeper since the previous inspection.

View of runoff erosion on the landside slope. Spring 2018.

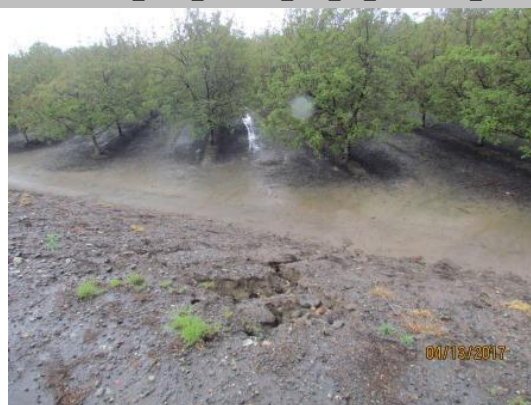
Photo 2 of 2 : SP_2018_RD0537_173_35_20180306_00030.jpg

View of runoff erosion on landside levee slope. Spring 2017.

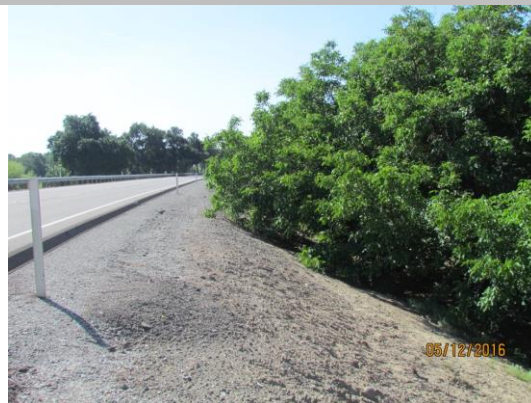
Photo 1 of 1 : SP_2018_RD0537_173_28_20180306_00022.jpg

View of the trees on the landward side of the levee looking downstream. Spring 2016.

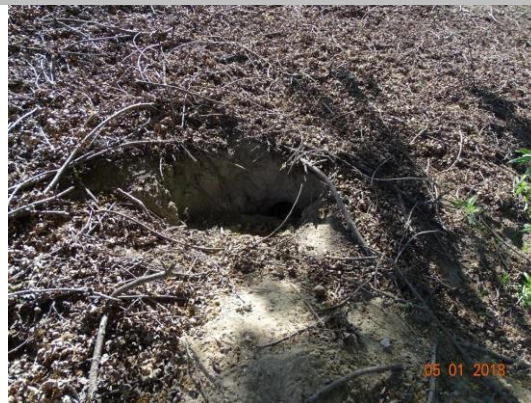
Photo 1 of 2 : SP_2018_RD0537_173_37_20180501_00096.jpg

View of rodent hole on the landside slope. Spring 2018.

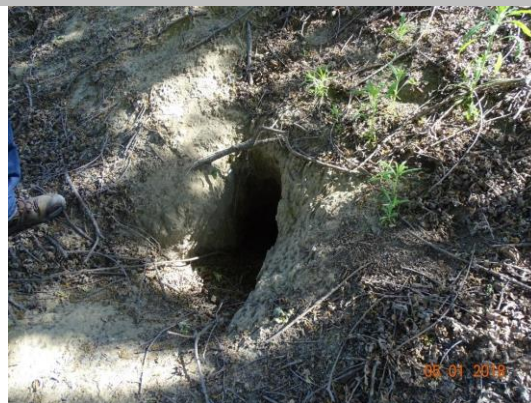
Photo 2 of 2 : SP_2018_RD0537_173_37_20180501_00097.jpg

Additional rodent hole on the landside slope. Spring 2018.

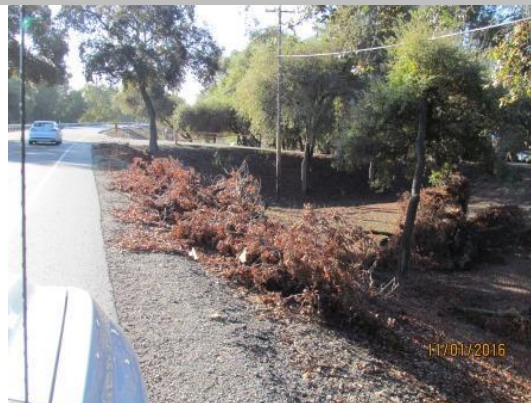
Photo 1 of 1 : SP_2018_RD0537_173_38_20180306_00034.jpg

View of debris on landside slope. Fall 2016.

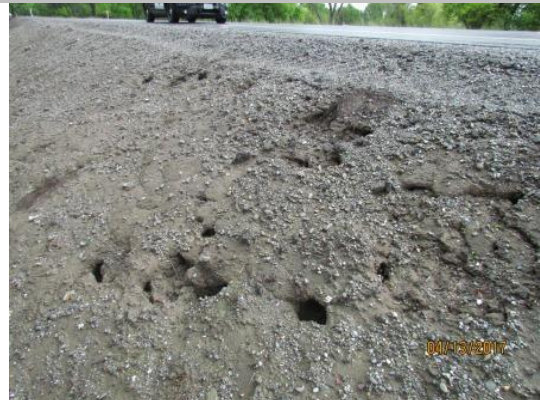
Photo 1 of 1 : SP_2018_RD0537_173_59_20180306_00057.jpg

View of rodent holes on landside levee slope. Spring 2017.

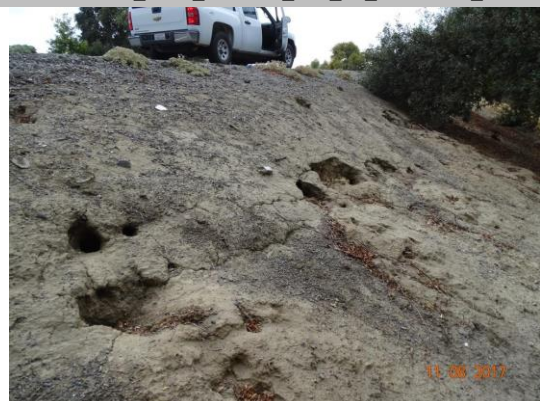
Photo 1 of 2 : SP_2018_RD0537_173_40_20180306_00036.jpg

Update view of rodent holes on the landside slope. Fall 2017.

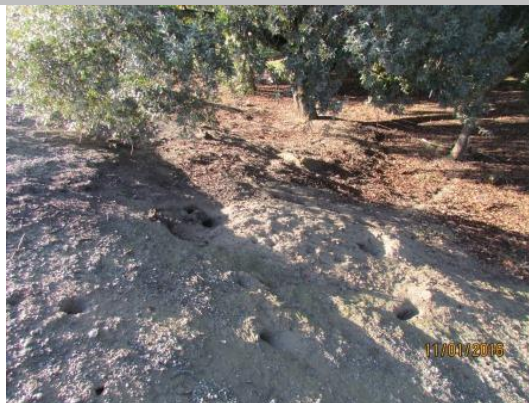
Photo 2 of 2 : SP_2018_RD0537_173_40_20180306_00037.jpg

View of rodent holes on LS slope. Fall 2016.

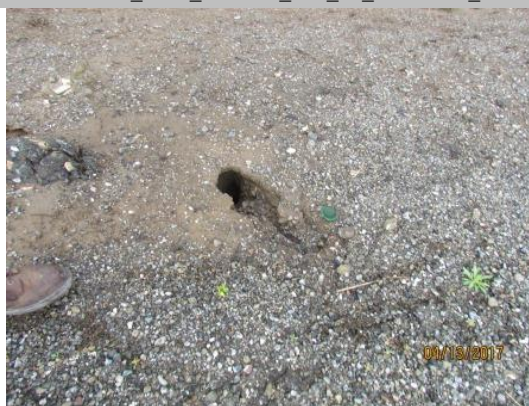
Photo 1 of 1 : SP_2018_RD0537_173_60_20180306_00058.jpg

Large burrow hole on landside levee slope. Spring 2017.

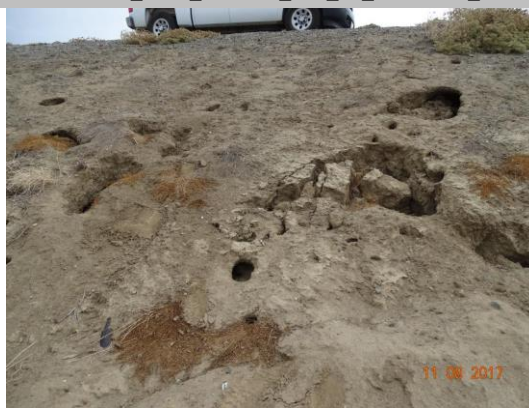
Photo 1 of 1 : SP_2018_RD0537_173_62_20180306_00059.jpg

View of rodent holes on the landside slope. Fall 2017.

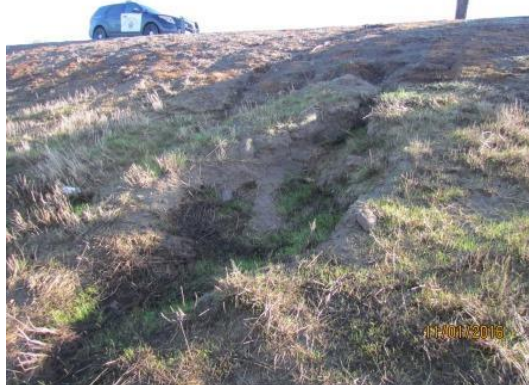
Photo 1 of 1 : SP_2018_RD0537_173_41_20180306_00038.jpg

LM Start	2.33	Rating **	M	Issue No.	41
LM End	2.33	Issue Type +	Ma	Location *	LS
Category	Earthen Levee			GPS Latitude/Longitude	
				Start	End
Item	Erosion / Bank Caving			38.627073 °	38.627073 °
				-121.563836 °	-121.563836 °
DWR ID	DWR_RD0537_01_f_2016_41				
Comment Code					
E2 : Schedule repair of erosion site prior to the next inspection.					
Inspector Comment

LS levee slope erosion. Fall 2016.

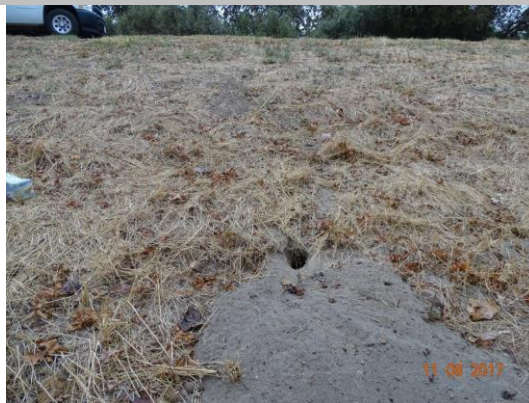
Photo 1 of 3 : SP_2018_RD0537_173_17_20180306_00013.jpg

Updated view of another rodent hole on the waterside slope. Fall 2017.

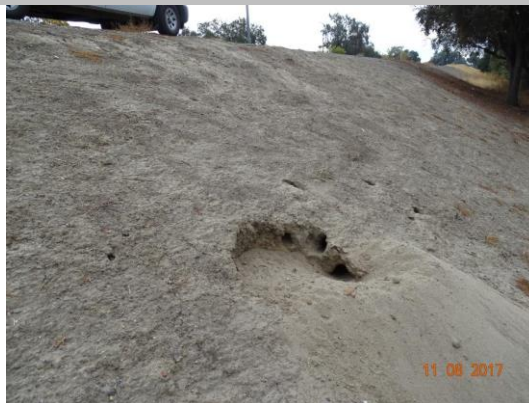
Photo 1 of 1 : SP_2018_RD0537_173_66_20180306_00061.jpg

View of rodent holes on the landside slope. Fall 2017.

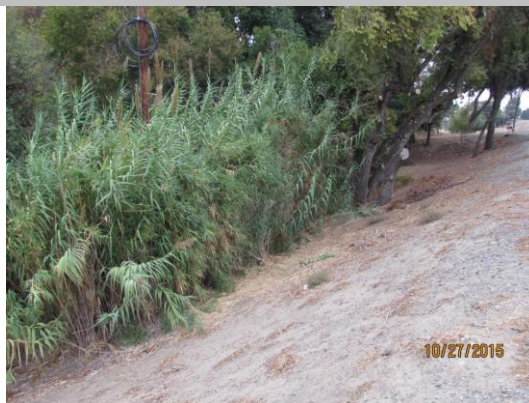
Photo 1 of 1 : SP_2018_RD0537_173_3_20180306_00002.jpg

View of the arundo at the levee toe on the landward side of the levee looking upstream. Fall 2015.

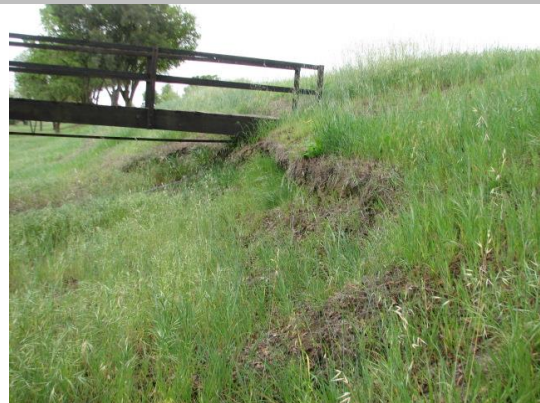
Photo 1 of 4 : SP_2018_RD0537_173_264_20180306_00064.jpg

Erosion cut 20 feet from the other one. Erosion 2-3 feet deep. Spring 2014

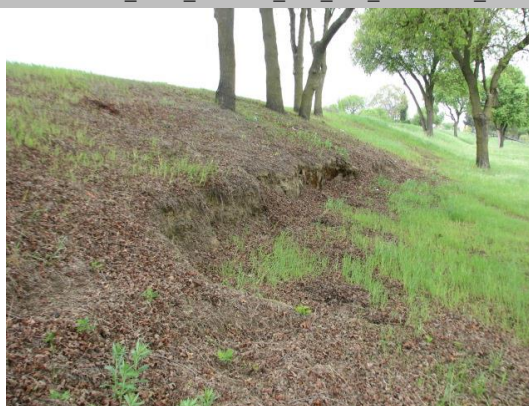
Photo 2 of 4 : SP_2018_RD0537_173_264_20180306_00065.jpg

Erosion cut in levee slope 2-3 feet deep. Spring 2014

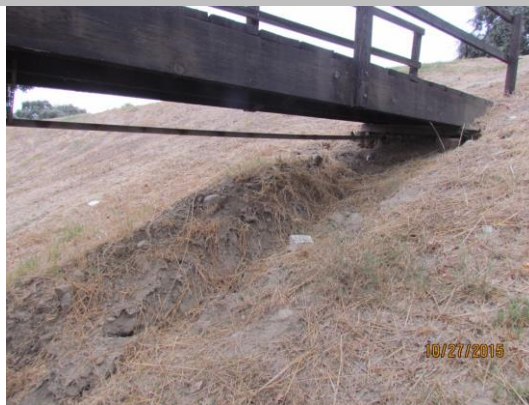
Photo 3 of 4 : SP_2018_RD0537_173_264_20180306_00066.jpg

There is erosion under the gangway on the waterward side of the levee looking downstream. Fall 2015.

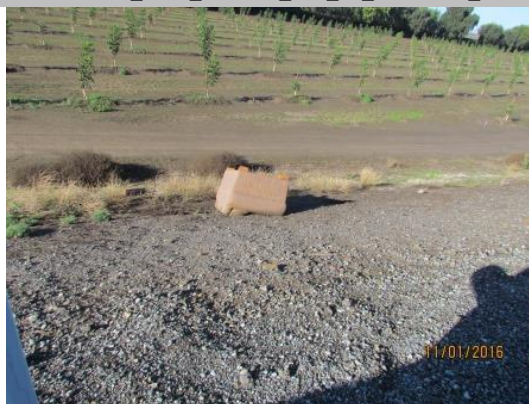
Photo 1 of 1 : SP_2018_RD0537_173_43_20180306_00040.jpg

Garbage on LS slope. Fall 2016.

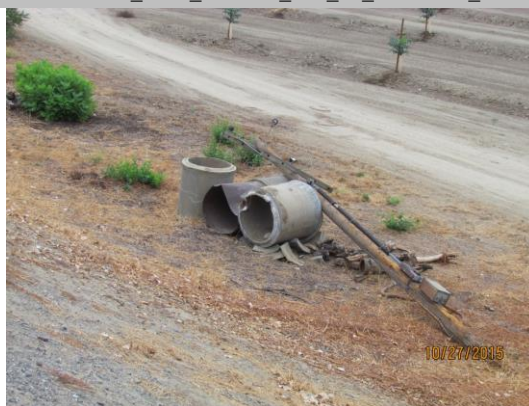
Photo 1 of 1 : SP_2018_RD0537_173_14_20180306_00008.jpg

View of concrete debris and a utility pole on the landward side of the levee. Fall 2015.

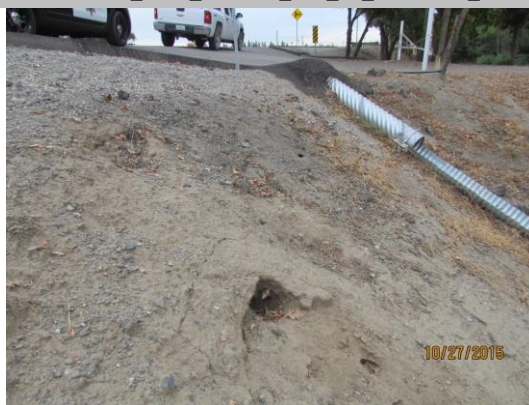
Photo 1 of 4 : SP_2018_RD0537_173_15_20180306_00009.jpg

View of the rodent hole on the landward side of the levee looking downstream. Fall 2015.

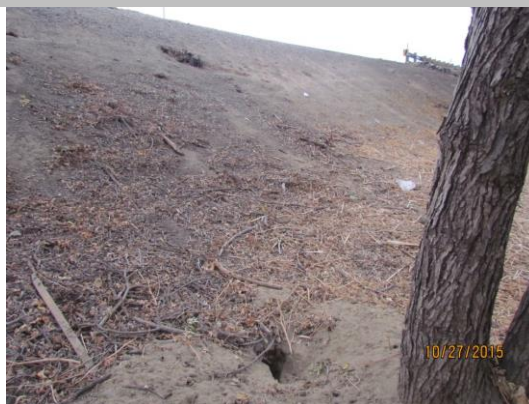
Photo 2 of 4 : SP_2018_RD0537_173_15_20180306_00010.jpg

More rodent holes a little further upstream. Fall 2015.

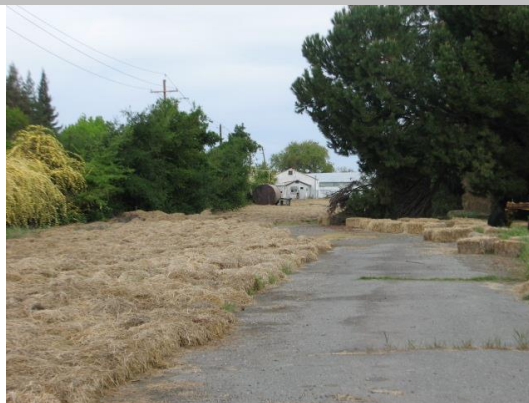
Photo 2 of 2 : SP_2018_RD0537_173_8_20180306_00007.jpg

Building and old equipment within the fenced compound. Spring 2014

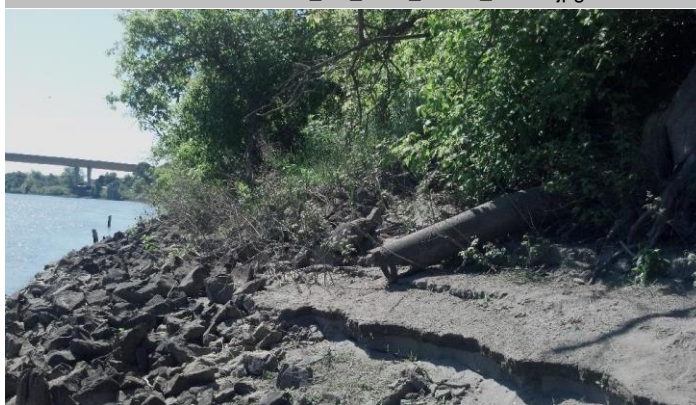
Photo 3 of 3 : UCIP_SP_2018_45026_74045.jpg

12" pipe along WS slope resting on possible remnant of pump house.

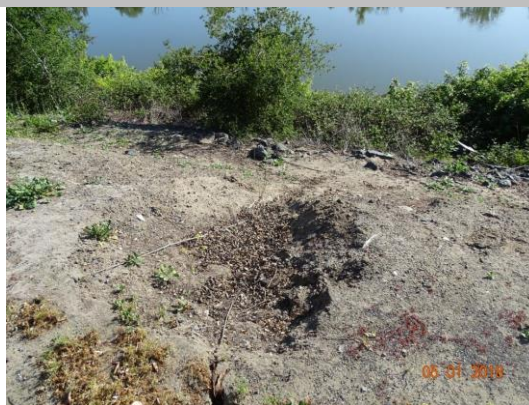
Photo 1 of 1 : SP_2018_RD0537_173_26_20180501_00092.jpg

View of runoff erosion on the waterside slope. Spring 2018.

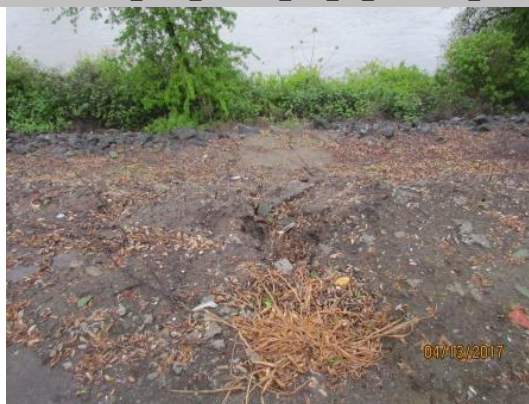
Photo 1 of 2 : SP_2018_RD0537_173_56_20180306_00054.jpg

View of first erosion location on waterside levee slope. Spring 2017.

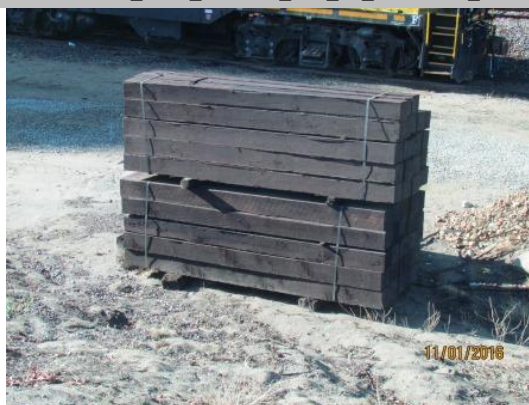
Photo 1 of 1 : SP_2018_RD0537_173_46_20180306_00041.jpg

Stock of RR rail ties at levee toe on landward side. Fall 2016.

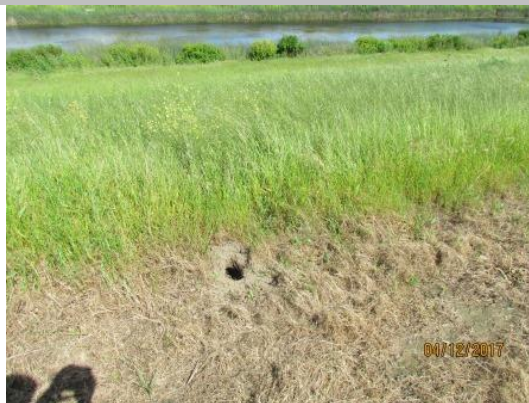
Photo 1 of 1 : SP_2018_RD0537_174_3_20180306_00001.jpg

View of burrow hole on landside levee slope. Spring 2017.
